SERMA TECHNOLOGIES

**HAMAMATSU PHOTODIODES (DPD-S8576)
EVALUATION REPORT
(GLAST Project)
REPORT E01P1435 - JUNE 2002**

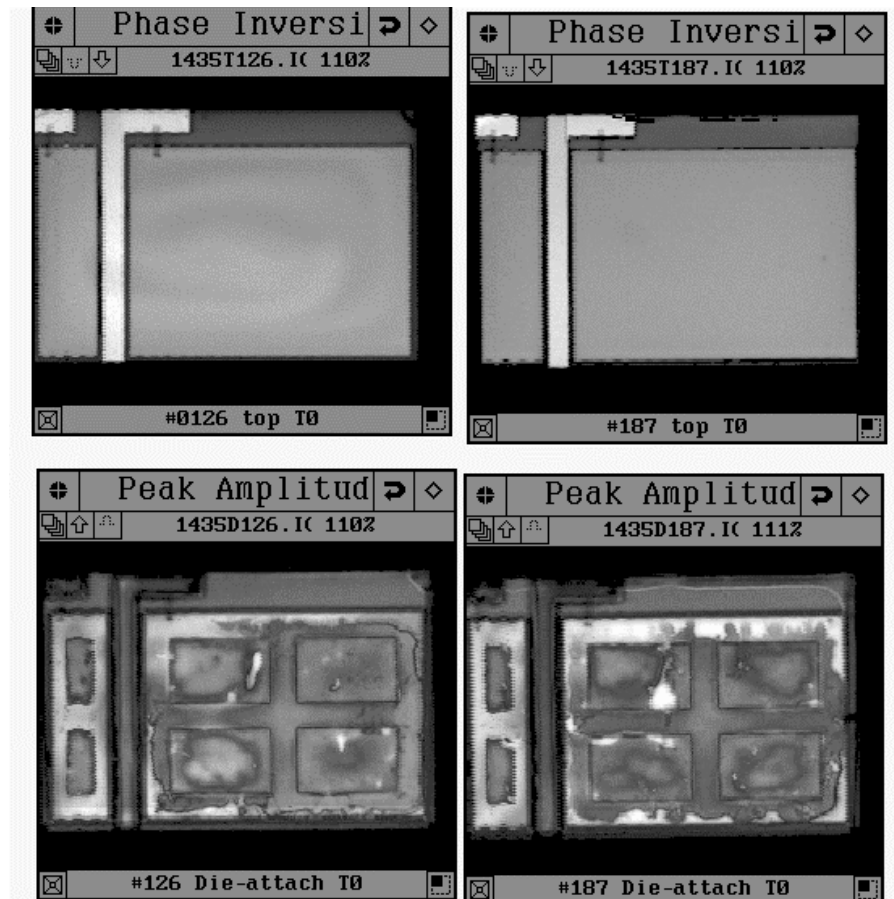
Figure 8. Acoustic microscopy, parts 126 and 187 ; Initial.
Top : delamination image ; epoxy / die, epoxy / ceramic.
Bottom : amplitude image, die-attach interface.

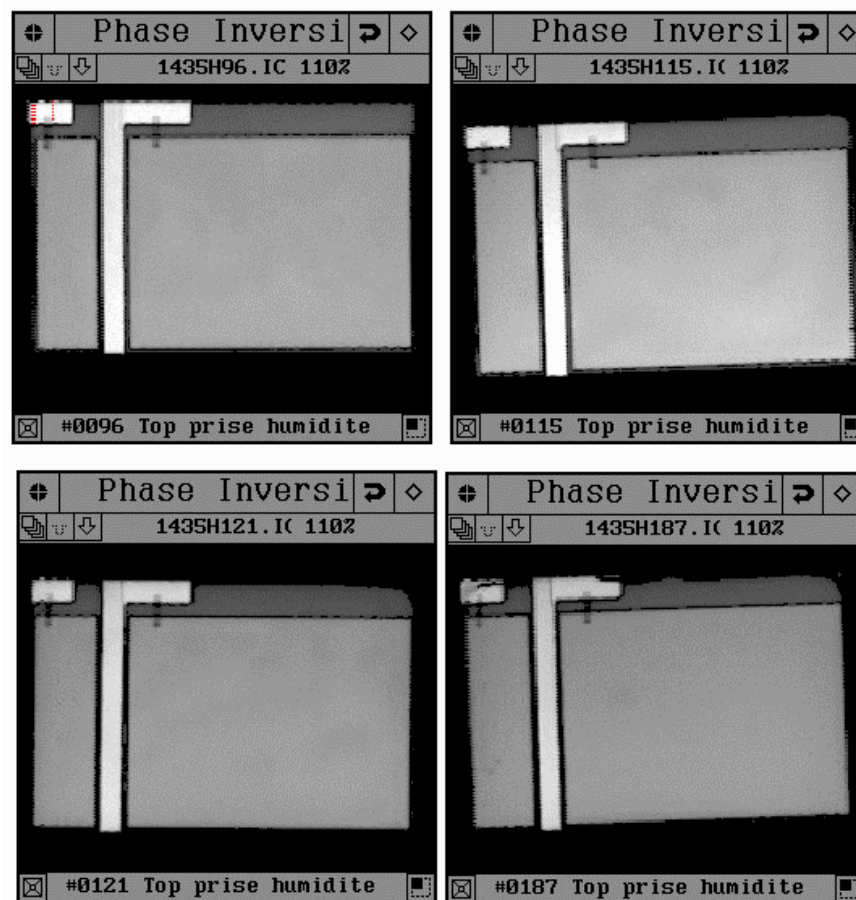
- * After temperature and humidity stress tests, on the 4 parts observed (96, 115, 121, 187), no delamination at epoxy / die and epoxy / ceramic interfaces was detected. There is no evolution of die-attach interface.

Figure 9. Acoustic microscopy, parts 96, 115, 121 and 187.
Temperature and humidity.
Delamination image ; epoxy / die, epoxy / ceramic.

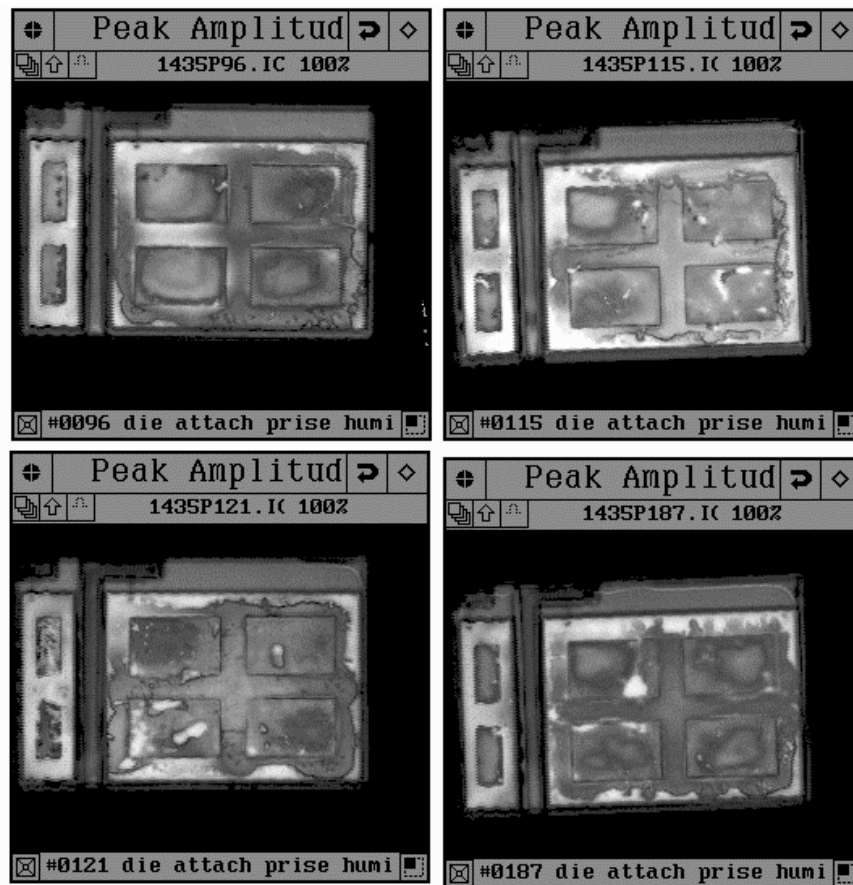
No die-attach voiding increase was noticed after temperature and humidity stress, Figure 10.

Figure 10. Acoustic microscopy, parts 96, 115, 121 and 187.
Temperature and humidity.
Amplitude image ; die-attach interface.

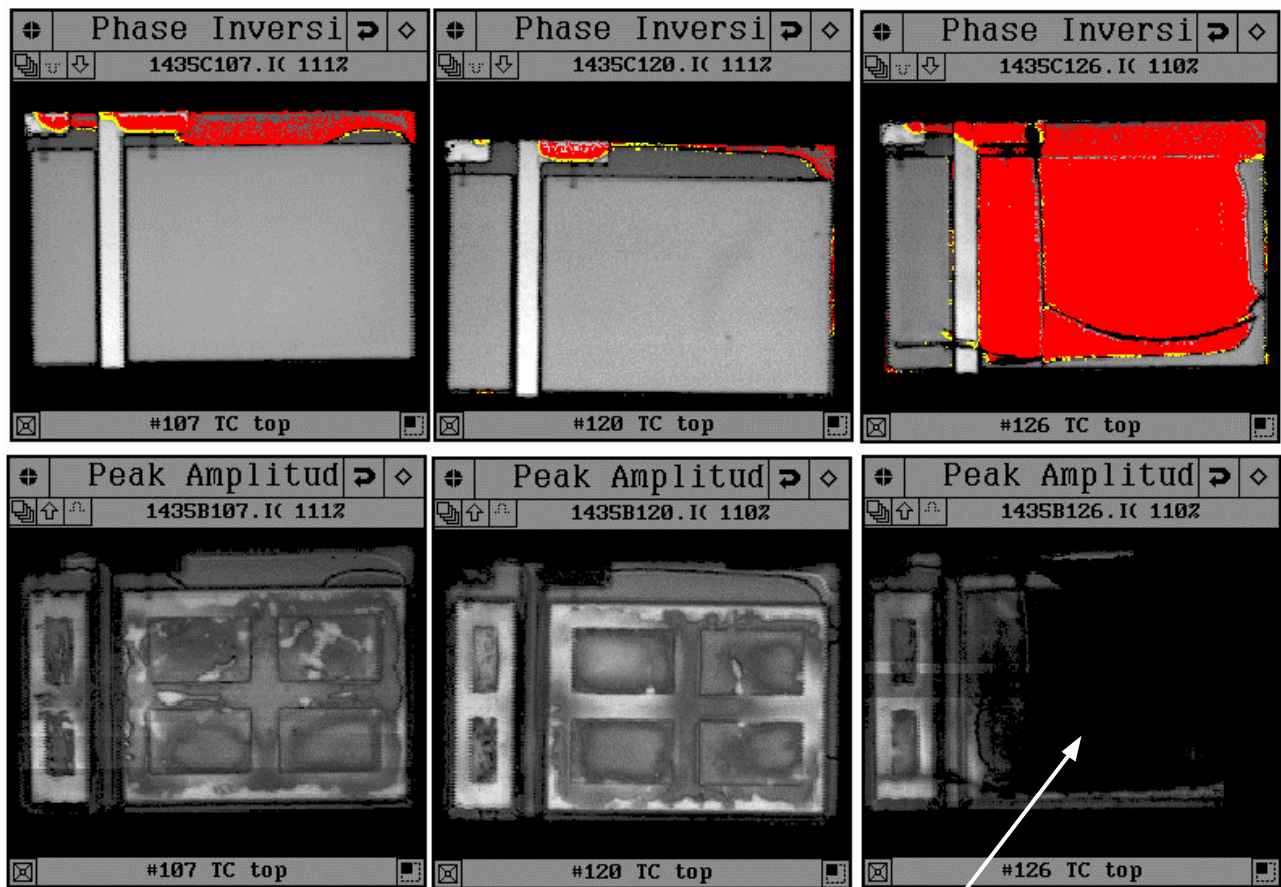
Note: on part # 126 after T.C. -30°C/80°C, the die attach can not be observed due to the delamination at epoxy / die interface

- * All along the temperature cycling stress tests, 15 parts were observed and some defects were detected :
 - delamination at epoxy / die on 3 parts (108, 109, 126) and cracks in epoxy on 2 parts (109, 126)

- there is no evolution of die-attach interface :
note : on Part 126 after TC-30°C, 180°C, the die attach cannot be observed due to the delamination at epoxy/die interface.

no signal due to
epoxy/die delamination

Figure 14. Acoustic microscopy, parts 107, 120 and 126.
Thermal cycling : -30°C / 80°C.
Top : delamination image ; epoxy / die, epoxy / ceramic.
Bottom : amplitude image, die-attach interface.

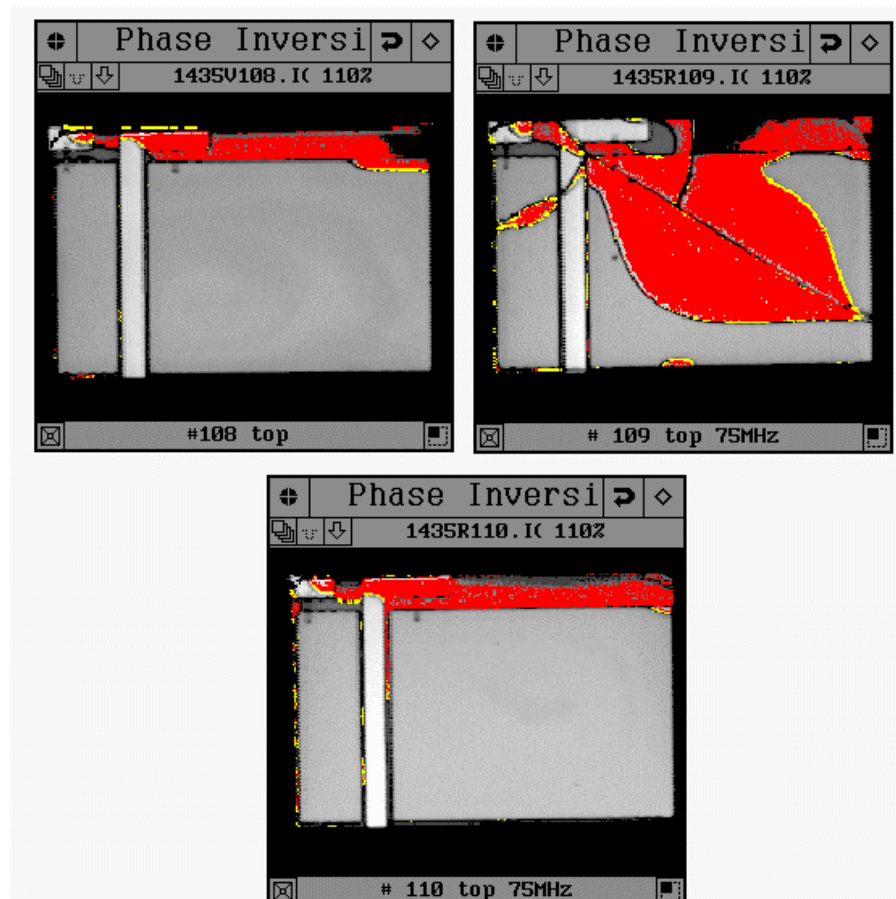
- One part (# 126) was found with crack on epoxy resin after T.C. -30°/80°C.
- A new T.C. stress (40 cycles -40°C/90°C) was performed on 3 remaining part from dry cell.
At the end of this supplementary stress again one part (# 109) was found with crack on epoxy resin.

Top Scanning	DELAMINATION AT INTERFACE	
Part reference (image ref.)	epoxy/die	epoxy/ ceramic
N°108 (1435V108)	Partial	Partial
N°109 (1435R109)	Partial 80% + cracks in epoxy	Partial
N°110 (1435R110)	No	Partial

Figure 15. Acoustic microscopy, parts 108 to 110.
Thermal cycling : -40°C / 90°C.
Top : delamination image ; epoxy / die, epoxy / ceramic.

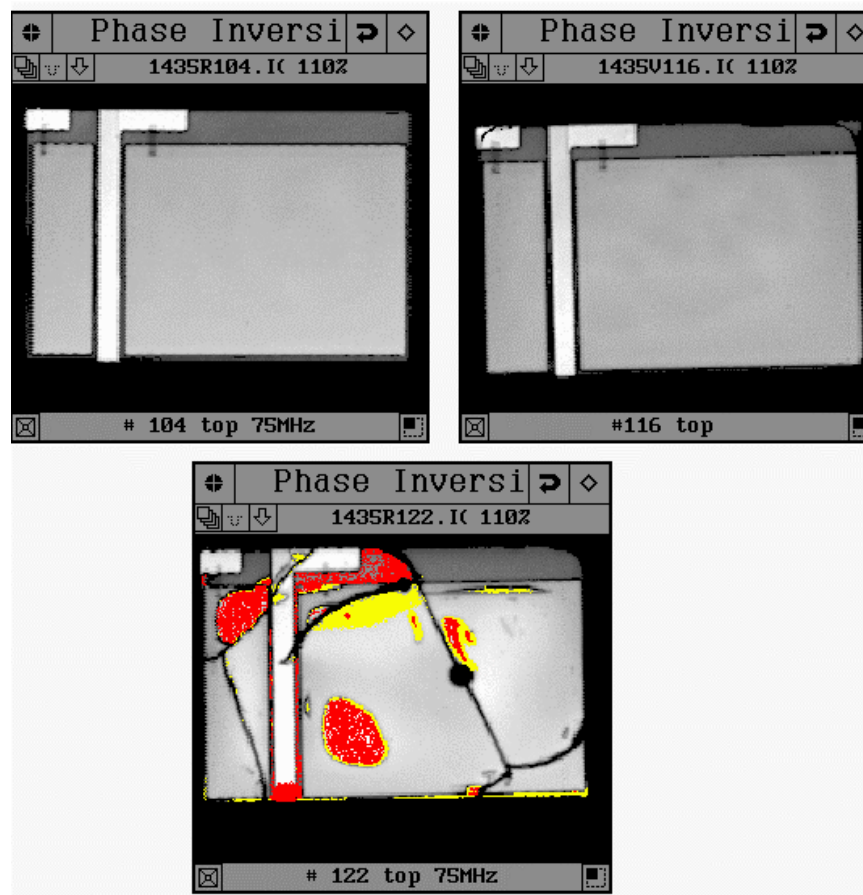
One of the DPDs, # 122 was found with crack on epoxy resin after 96 hours over the 168 hours storage at -40°C .

- * After 168 hours storage at -40°C, on the 3 parts observed (104, 116, 122, already analysed during thermal cycling) one part (122) was found with cracks in epoxy and partial delamination at epoxy / ceramic interfaces and epoxy / die. There is no evolution on the other parts. No observation was done at die attach interface.

Top Scanning	DELAMINATION AT INTERFACE	
Part reference (image ref.)	epoxy/die	epoxy/ ceramic
N°104 (1435R104)	No	No
N°116 (1435V116)	No	No
N°122 (1435R122)	Partial + cracks in epoxy: the delaminated area size is minimized by the presence of water in the diode package.	Partial

Figure 16. Acoustic microscopy, parts 104, 116 and 122.
Stress : -40°C, 168 hours.
Top : delamination image ; epoxy / die, epoxy / ceramic.

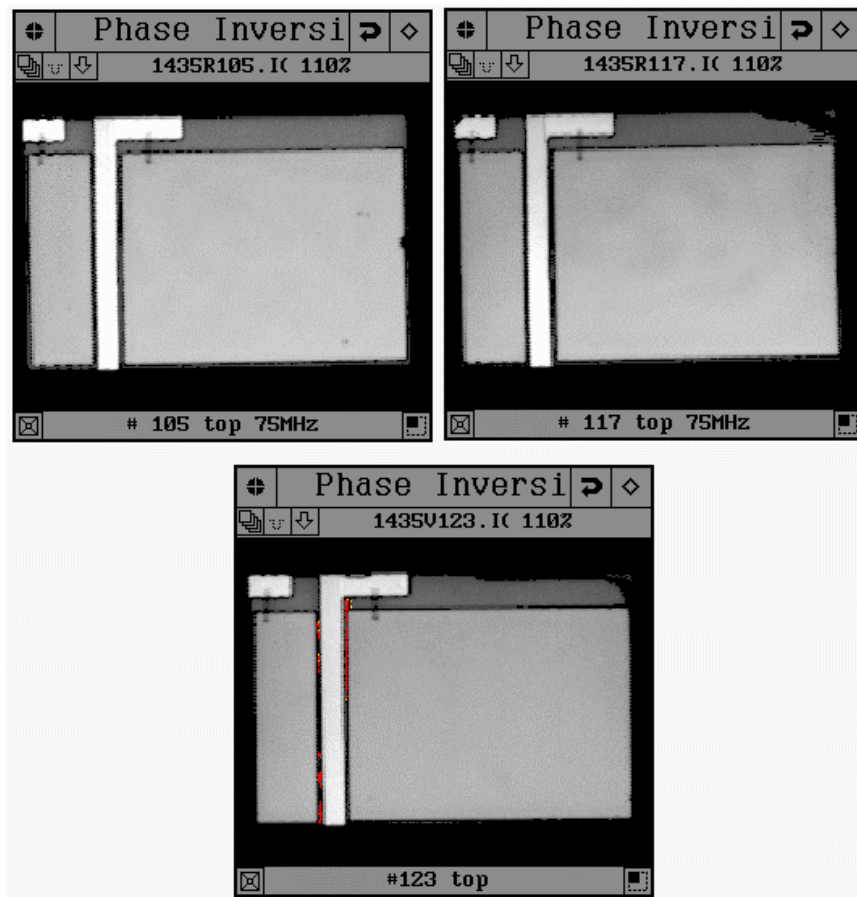
No defect found after 168 hours at 90°C .

- * After 168 hours storage at 90°C, on the 3 parts observed (105, 117, 123 already analysed during thermal cycling) no delamination evolution was detected, only part 123 show a beginning of delamination at epoxy / ceramic interface. No observation was done at die attach interface.

Figure 17. Acoustic microscopy, parts 105, 117 and 123.
Stress : 90°C, 168 hours.
Top : delamination image ; epoxy / die, epoxy / ceramic.

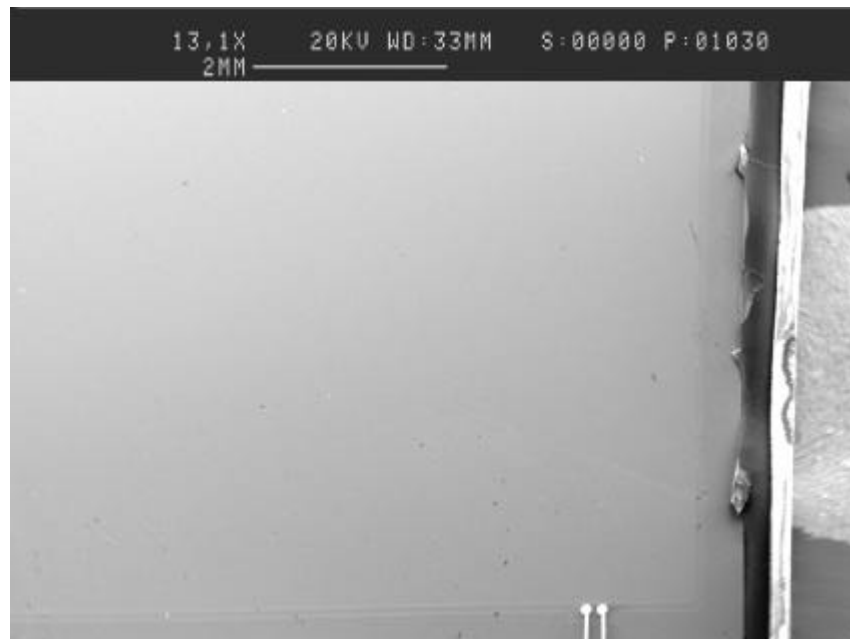
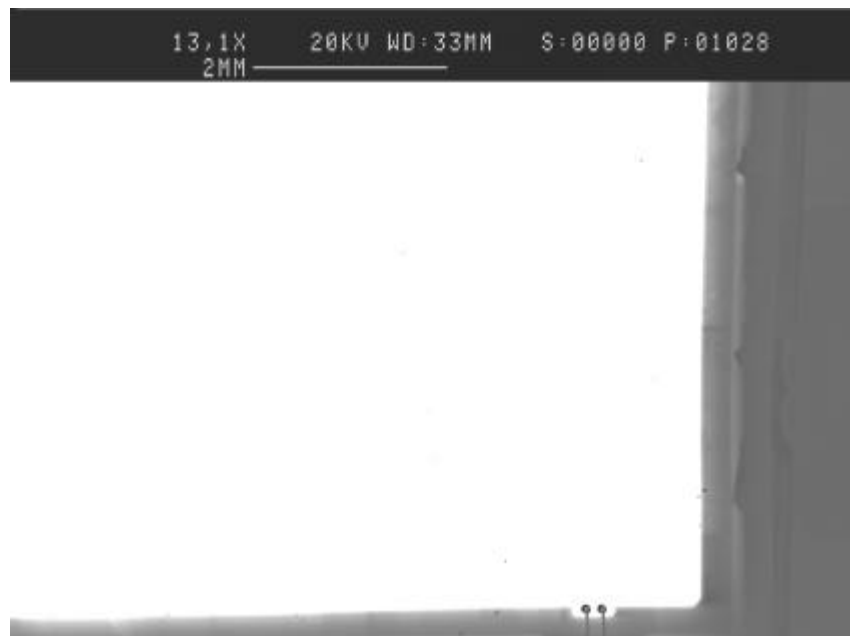
- A SEM inspection by secondary electrons (ES) and by electrons beam induced current (EBIC) did not reveal any defect (Part 0096 and 0187, Pin B).
No defect as black areas characteristic of defect in the bulk was identified in this part.
This EBIC technique appeared satisfactory in order to inspect defect in the die.

Figure 2. SEM detailed views of the die surface, Pin B, # 0096, mag 13X.
Top : secondary electrons view ; bottom : EBIC view.

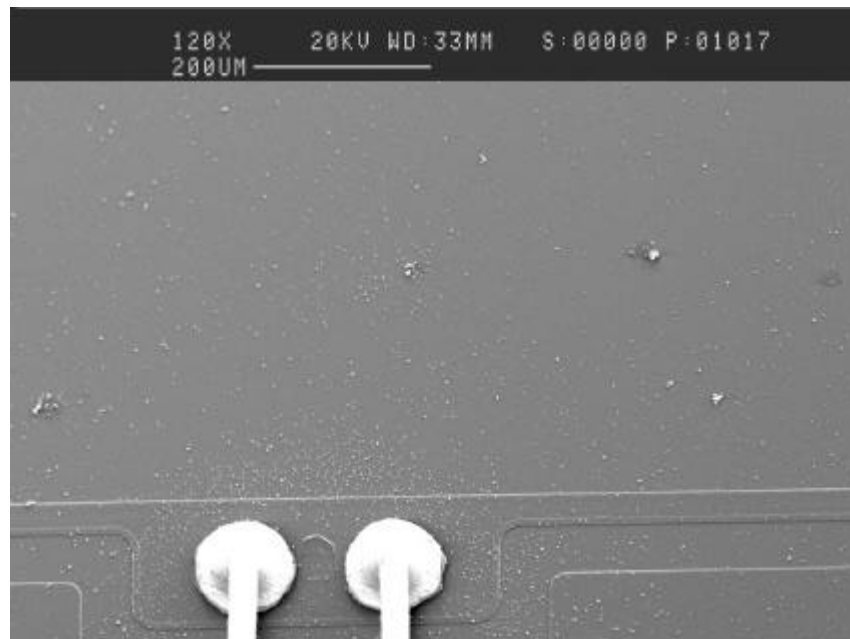
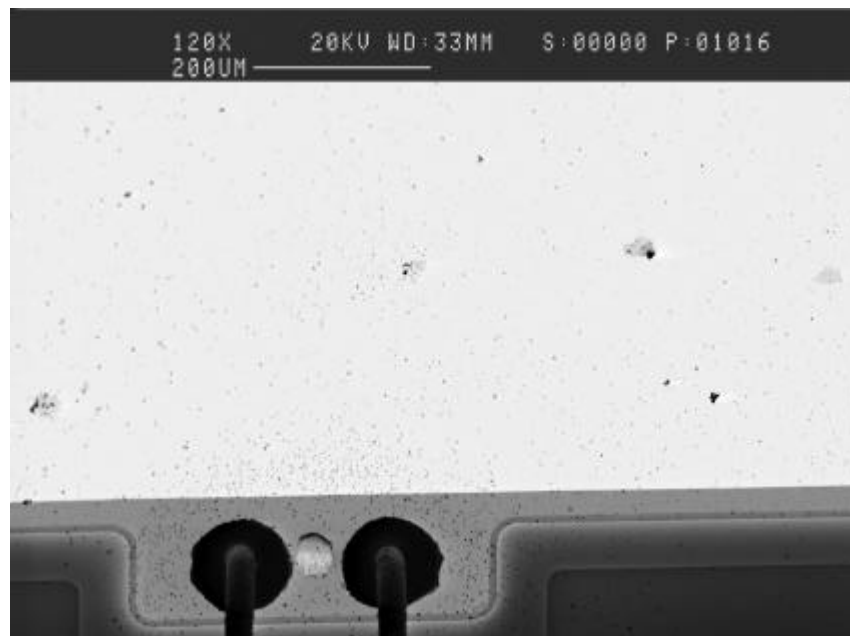
Figure 3. SEM detailed views of the die surface, Pin B, # 0096, mag 120X.
Top : secondary electrons view ; bottom : EBIC view.

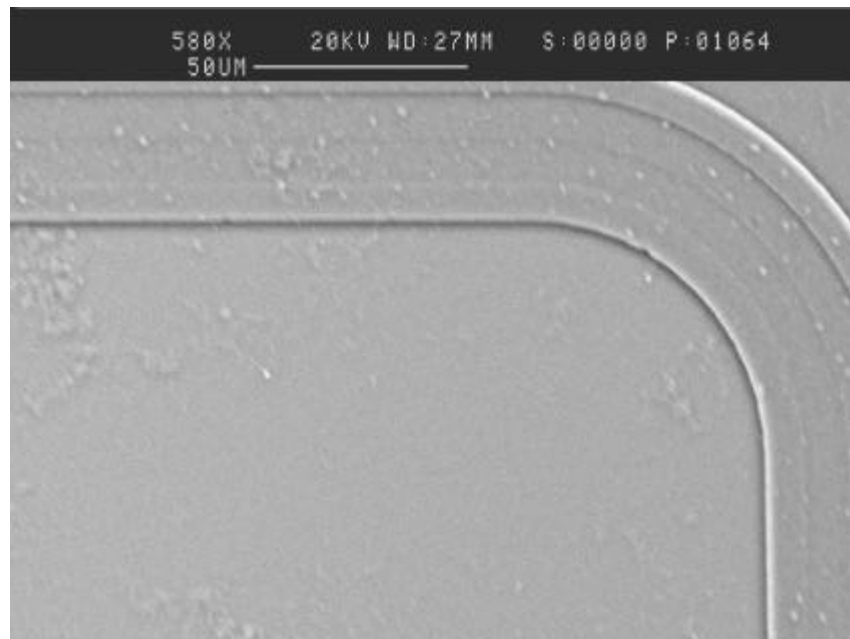
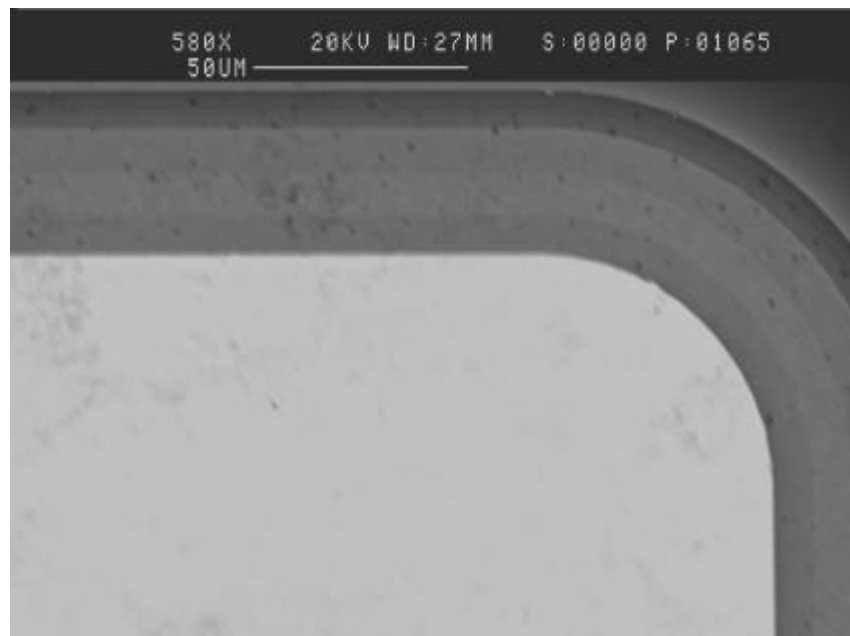
Figure 4. SEM detailed views of the die surface, Pin B, # 0187, mag 580X.
Top : secondary electrons view ; bottom : EBIC view.

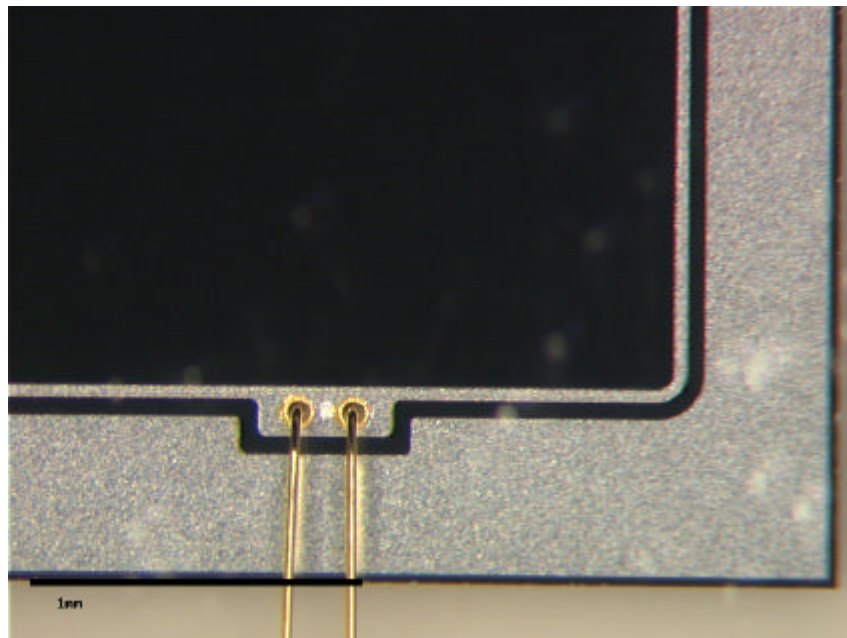
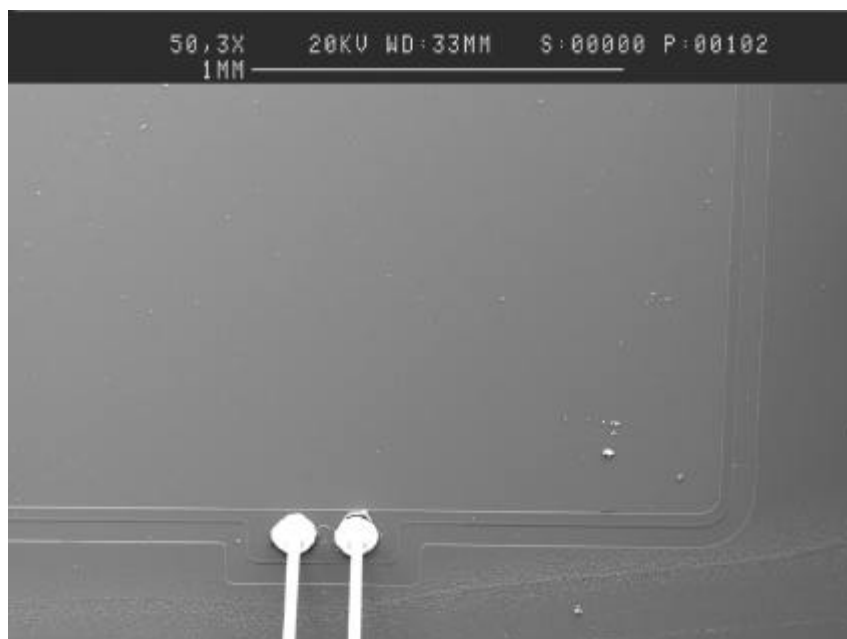
- The Part 0128 Pin B with correct dark current was used for comparison with the other parts : no difference was observed.

Figure 5. Optical and SEM detailed views of the die surface, Pin B, # 0128.
 Top : optical view, mag 45X ; center : Secondary Electrons SEM view, mag 5X ;
 Bottom : EBIC SEM view, mag 50X.

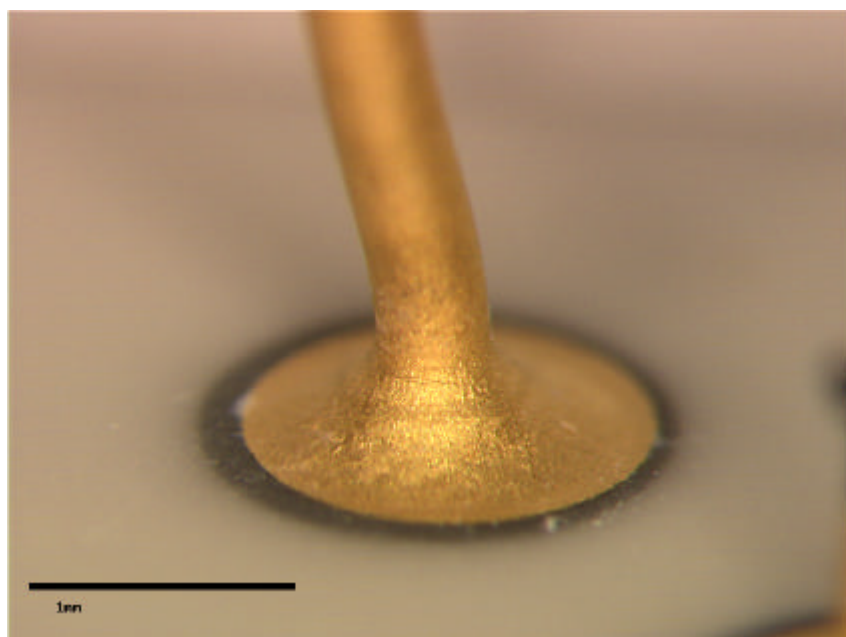
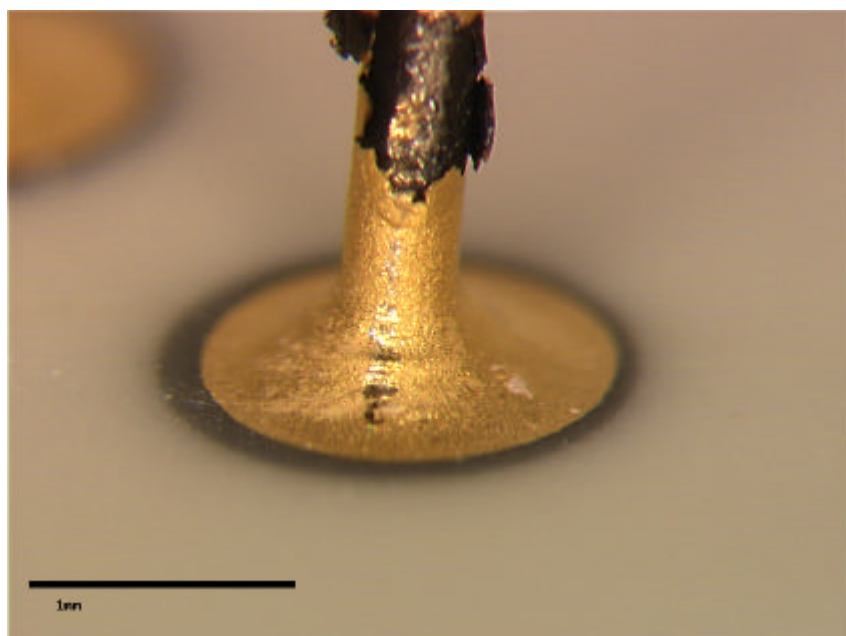
- one lead was bent a number of time sufficient to be broken : five bends at 90° were performed from vertical axis. For this stress, the lead was held with a pliers close to the case, that was a very strong stress

This test confirms the good mechanical strength of the lead.

Figure 1. Optical views of lead bases after bending test, $\approx 36X$.

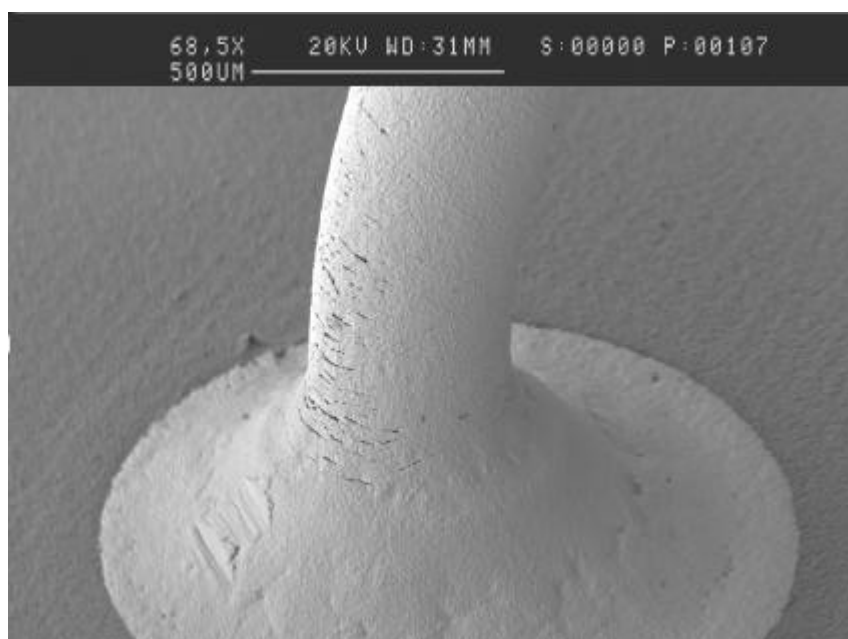
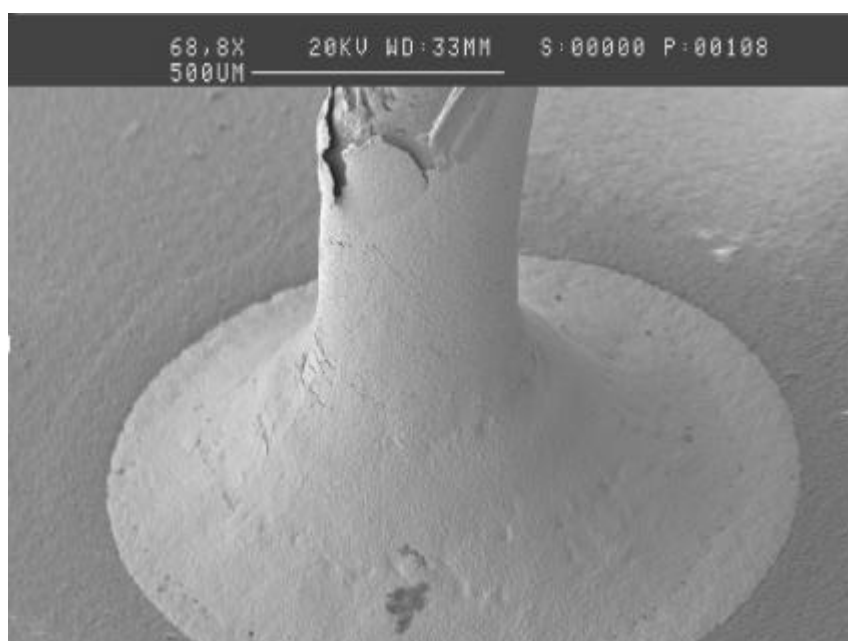
Figure 3. SEM views of lead bases after bending test, $\approx 70X$.

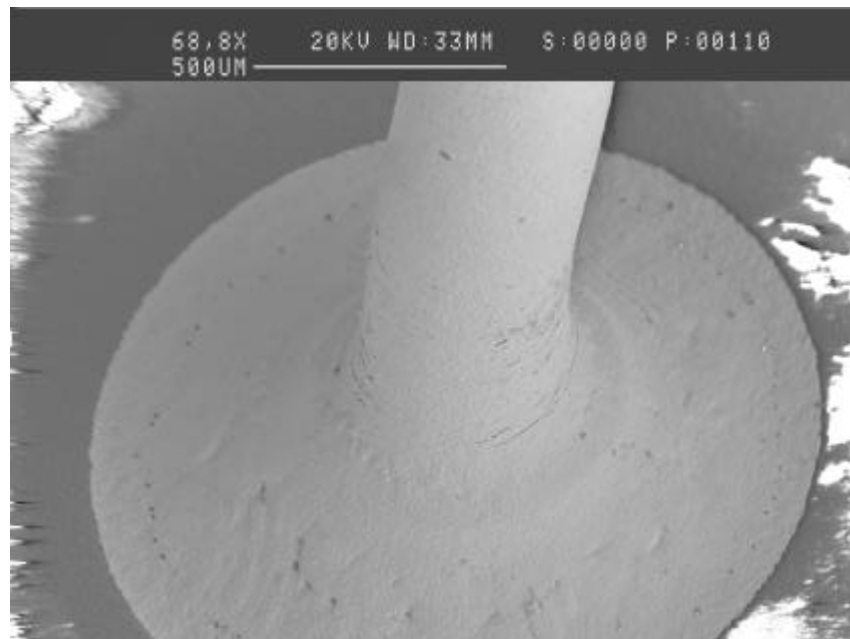
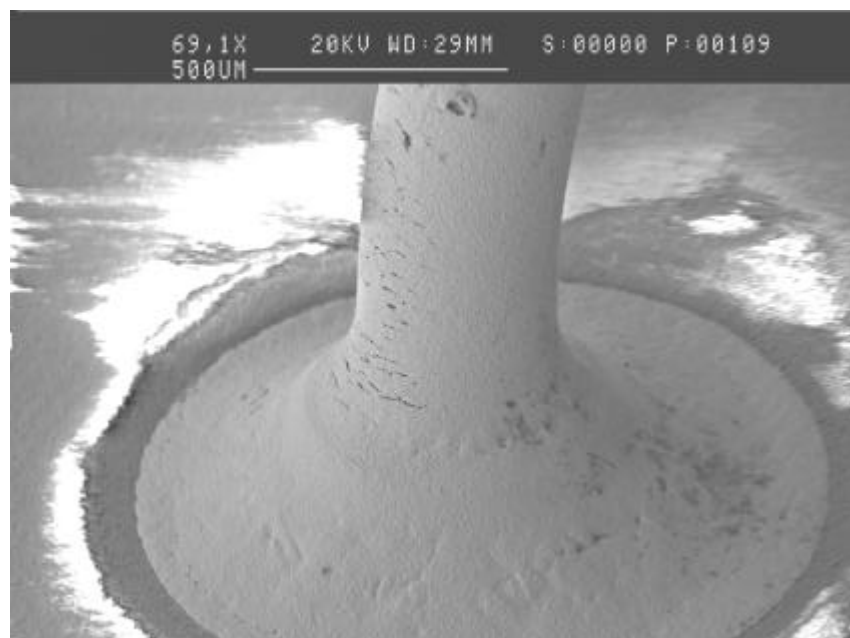
Figure 4. SEM views of lead bases after bending test, $\approx 70X$.
